2020

MRCC Significant Tree Register

***A Reference Guide to Significant Trees on Council
Land in the Municipality of Mildura***

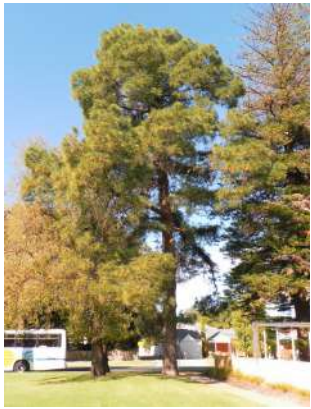
Genus & Species:	<i>Pinus canariensis</i>	
	Tree Group Identifier No:	6	
	Tree No:	23	
Location & Access:	Location (Street Address or Park Name):	199 Cureton Avenue, Mildura, Rio Vista House, Mildura	
	Access:	Unrestricted	
	GIS Coordinates:	6217529.7460000003 (N) / 606828.90000000002 (E)	
<i>For mapping please refer to Tree Group Identification No 6 on Mildura (Arts Centre-A) town map in Appendix 1</i>			
Assessment:	National Trust Australia (Vic) Heritage Register:	No	
	National Trust Australia (Vic) Criteria for Classification and Assessment:	Location or Context: Contribution to Landscape	
	MPS Heritage Overlay:	Tree covered by HO307 in the Mildura Planning Scheme	
	Heritage Victoria Criteria for Classification and Assessment:	Referred for Assessment in Stage 2 of MRCC Heritage Study Part B	
Field Description:	Tree Health:	Very Good	
	Tree Structure & Condition:	Good Structure

Note:	Comments below	
Dimensions:	Canopy (Planting Width/East West & North South Spread)	4m - 6m / EW 12m NS 17m	
	Measured Height:	23.5m	
	Measured DBH:	0.8m	
	Overall Height Estimate:	3m - 6m	
Threats & Remedies:	Threats:	Redevelopment of Rio Vista, footpath maintenance of the adjoining path which runs in along the property boundary to the house and gallery.	
	Remedial Action:	Ensure tree is protected during any reconstruction of the path in close proximity.	
Comments:	No comment required.		
	Assessment Completed by:	Gareth Tyson	
	Assessment Completed date:	10 May 2012

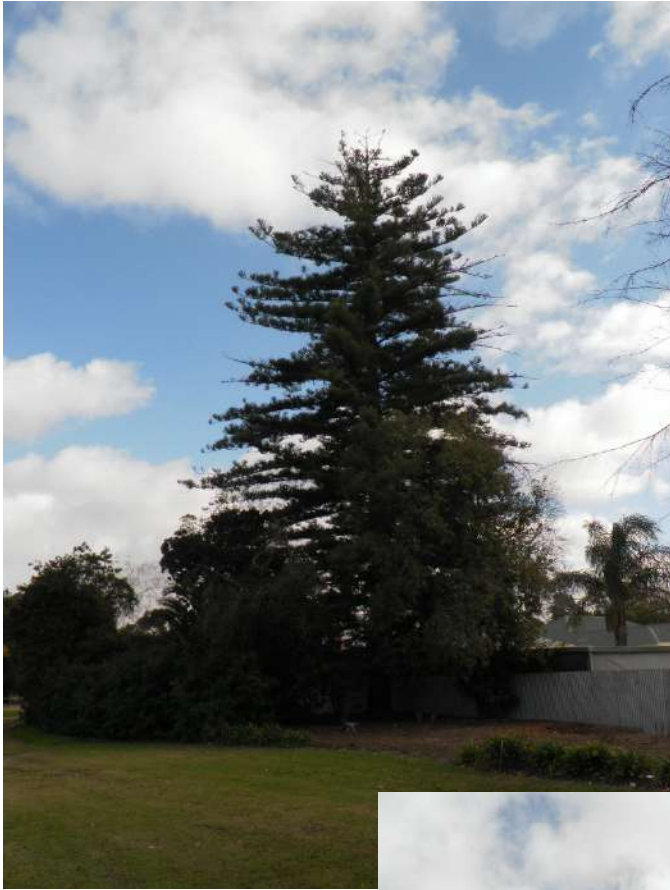
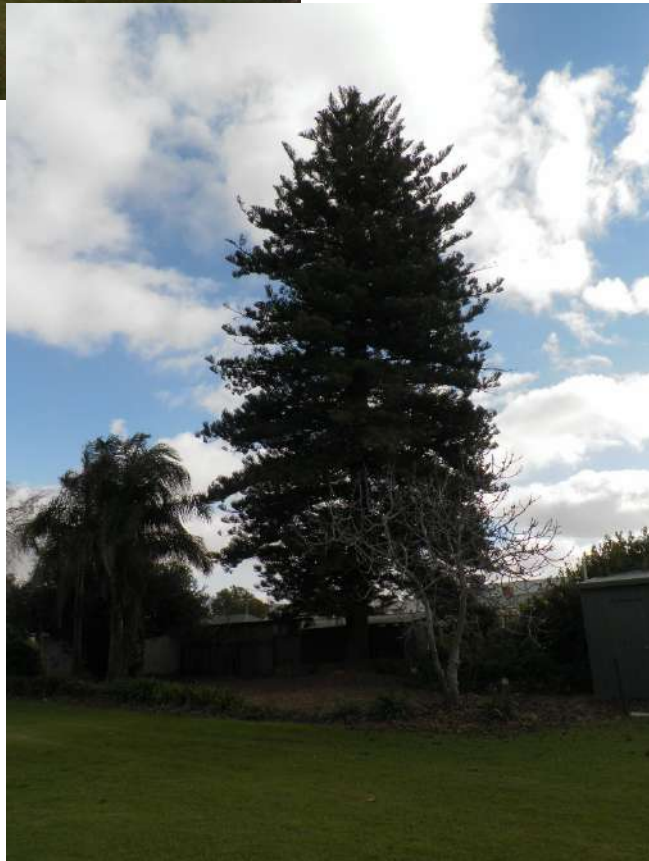
Identification:	Common Name:	Aleppo Pine	 
	Genus & Species:	Pinus halepensis	
	Tree Group Identifier No:	24	
	Tree No:	112	
Location & Access:	Location (Street Address or Park Name):	Corner of Sixth Street, Mildura and Cureton Avenue, Mildura	
	Access:	Unrestricted	
	GIS Coordinates:	6217839.5130000003 (N) / 606729.86600000004 (E)	
For mapping please refer to Tree Group Identification No 24 on Mildura (Arts Centre-A) town map in Appendix 1			
Assessment:	National Trust Australia (Vic) Heritage Register:	No	
	National Trust Australia (Vic) Criteria for Classification and Assessment:	Location or Context: Contribution to Landscape Aesthetic Value	
	MPS Heritage Overlay:	No	
	Heritage Victoria Criteria for Classification and Assessment:	Referred for Assessment in Stage 2 of MRCC Heritage Study Part B	
Field Description:	Tree Health:	Very Good	
	Tree Structure & Condition:	Poor - Co-dominant or Bifurcated Stems

Note:		
Dimensions:	Canopy (Planting Width/East West & North South Spread)	4m - 6m / EW 17.4m NS 17.3m	
	Measured Height:	16.4m	
	Measured DBH:	South 0.6m North 0.78m	
	Overall Height Estimate:	3m - 6m	
Threats & Remedies:	Threats:	Garden/lawn maintenance activities.	
	Remedial Action:	Educate land managers about suitable maintenance options in close proximity to the tree. Minimise damage to the trunk and lower canopy.	
Comments:	No comment required.		
	Assessment Completed by:	Gareth Tyson	
	Assessment Completed date:	15 May 2012

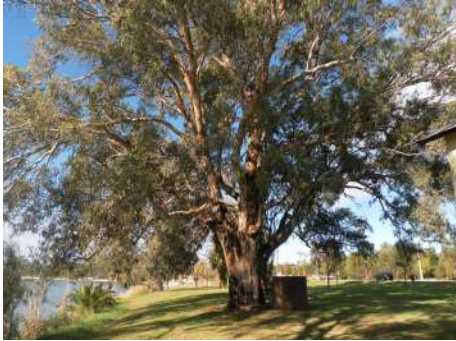
Genus & Species:	Eucalyptus camaldulensis	
	Tree Group Identifier No:	40	
	Tree No:	265	
Location & Access:	Location (Street Address or Park Name):	Riverfront, Mildura (Near old pump building opposite Powerhouse) & Jaycee Park, Mildura	
	Access:	Unrestricted	
	GIS Coordinates:	6217208.7980000004 (N) / 607333.73199999996 (E)	
For mapping please refer to Tree Group Identification No 40 on Mildura (CBD-B) town map in Appendix 1			
Assessment:	National Trust Australia (Vic) Heritage Register:	No	
	National Trust Australia (Vic) Criteria for Classification and Assessment:	Location or Context: Contribution to Landscape	
	MPS Heritage Overlay:	No	
	Heritage Victoria Criteria for Classification and Assessment:	Referred for Assessment in Stage 2 of MRCC Heritage Study Part B	
Field Description:	Tree Health:	Good	
	Tree Structure & Condition:	Good Structure	
	Note:	Comments below

Tree Structure & Condition:	Poor - Co-dominant or Bifurcated Stems
	Note:	Comments below
Dimensions:	Canopy (Planting Width/East West & North South Spread)	4m - 6m / EW 10m NS 8m
	Measured Height:	11.8m
	Measured DBH:	1.42m
	Overall Height Estimate:	3m - 6m
Threats & Remedies:	Threats:	Redevelopment of Rio Vista House and the courtyard area.
	Remedial Action:	Ensure that the tree is protected during any redevelopment
Comments:	No comment required.	
	Assessment Completed by:	Gareth Tyson
	Assessment Completed date:	29 June 2012

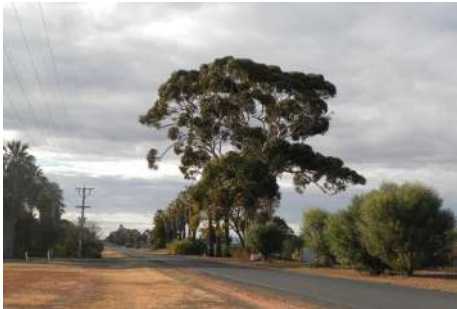
Genus & Species:	<i>Eucalyptus cladocalyx</i>	
	Tree Group Identifier No:	52	
	Tree No:	373	
Location & Access:	Location (Street Address or Park Name):	309 Third Street, Merbein	
	Access:	Unrestricted	
	GIS Coordinates:	6219335.7039999999 (N) / 594608.50800000003 (E)	
<i>For mapping please refer to Tree Group Identification No 52 on Merbein (Key) town map in Appendix 1</i>			
Assessment:	National Trust Australia (Vic) Heritage Register:	No	
	National Trust Australia (Vic) Criteria for Classification and Assessment:	Location or Context: Contribution to Landscape Rare or localised	
	MPS Heritage Overlay:	No	
	Heritage Victoria Criteria for Classification and Assessment:	Referred for Assessment in Stage 2 of MRCC Heritage Study Part B	
Field Description:	Tree Health:	Good	
	Tree Structure & Condition:	Poor - Co-dominant or Bifurcated Stems	
	Note:	Comments below

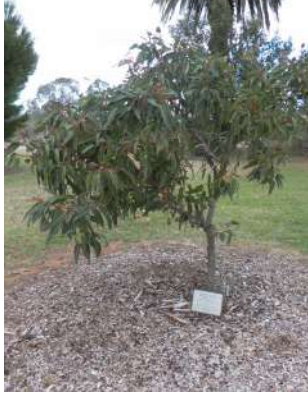
Genus & Species:	<i>Corymbia ficifolia</i>	
	Tree Group Identifier No:	53	
	Tree No:	374	
Location & Access:	Location (Street Address or Park Name):	Kenny Park, Merbein (Near Rotunda)	
	Access:	Unrestricted	
	GIS Coordinates:	6218950.4850000003 (N) / 597224.06400000001 (E)	
<i>For mapping please refer to Tree Group Identification No 53 on Merbein (Key) town map in Appendix 1</i>			
Assessment:	National Trust Australia (Vic) Heritage Register:	No	
	National Trust Australia (Vic) Criteria for Classification and Assessment:	Location or Context: Contribution to Landscape Historical Value	
	MPS Heritage Overlay:	No	
	Heritage Victoria Criteria for Classification and Assessment:	Referred for Assessment in Stage 2 of MRCC Heritage Study Part B	
Field Description:	Tree Health:	Good	
	Tree Structure & Condition:	Poor - Co-dominant or Bifurcated Stems	
	Note:	Comments below

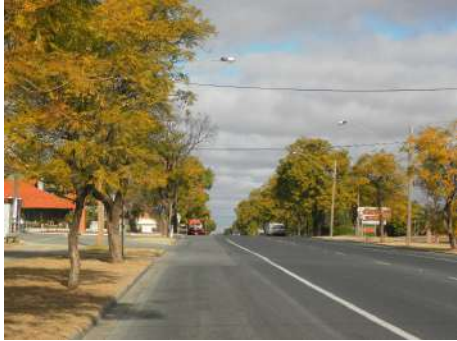
Genus & Species:	<i>Jacaranda mimosifolia</i>	
	Tree Group Identifier No:	55	
	Tree No:	376-413	
Location & Access:	Location (Street Address or Park Name):	3-101 Jacaranda Street, Red Cliffs 1 Indi Avenue, Red Cliffs	
	Access:	Unrestricted	
	GIS Coordinates:	6202603.8119999999 (N) / 609176.174 (E)	
	<i>For mapping please refer to Tree Group Identification No 55 on Red Cliffs (Barclay Square) town map in Appendix 1</i>		
Assessment:	National Trust Australia (Vic) Heritage Register:	No	
	National Trust Australia (Vic) Criteria for Classification and Assessment:	Location or Context: Contribution to Landscape	
	MPS Heritage Overlay:	No	
	Heritage Victoria Criteria for Classification and Assessment:	Referred for Assessment in Stage 2 of MRCC Heritage Study Part B	
Field Description:	Tree Health:	Good	
	Tree Structure & Condition:	376-383, 385-389, 392-395, 399, 401-405, 407-412 Good Structure 384, 390, 396, 413 Poor – Co-dominant or Bifurcated Stem 391, 397 Poor - Major Trunk Wound 398, 400, 406 Poor – Trunk Decay

376-380, 383-389 Educate land managers about the suitable maintenance options in close proximity to the tree to minimise damage to any parts above or below ground.

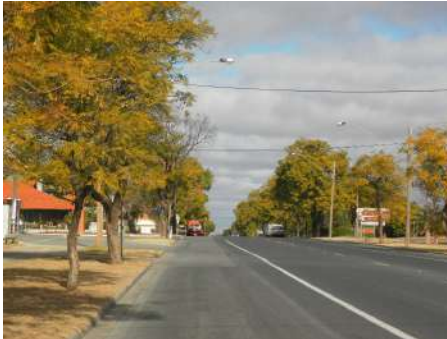
Genus & Species:	Jacaranda mimosifolia	
	Tree Group Identifier No:	55	
	Tree No:	478-480	
Location & Access:	Location (Street Address or Park Name):	Calder Highway, Red Cliffs (Heading to Werrimull Road from Red Cliffs)	
	Access:	Unrestricted	
	GIS Coordinates:	6201876.7149999999 (N) / 609170.38300000003 (E)	
For mapping please refer to Tree Group Identification No 55 on Red Cliffs (Barclay Square) town map in Appendix 1			
Assessment:	National Trust Australia (Vic) Heritage Register:	No	
	National Trust Australia (Vic) Criteria for Classification and Assessment:	Location or Context: Contribution to Landscape	
	MPS Heritage Overlay:	No	
	Heritage Victoria Criteria for Classification and Assessment:	Referred for Assessment in Stage 2 of MRCC Heritage Study Part B	
Field Description:	Tree Health:	Good	
	Tree Structure & Condition:	Poor - Co-dominant or Bifurcated Stems

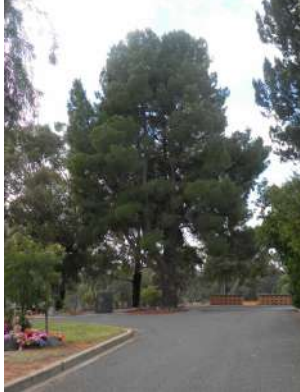
Identification:	Common Name:	Aleppo Pine
	Genus & Species:	<i>Pinus halepensis</i>
	Tree Group Identifier No:	64
	Tree No:	506
Location & Access:	Location (Street Address or Park Name):	Nichols Point Cemetery, Nichols Point
	Access:	Unrestricted
	GIS Coordinates:	6215790.7560000001 (N) / 612170.51199999999 (E)

<p><i>For mapping please refer to Tree Group Identification No 64 on Nichols Point (Key) town map in Appendix 1</i></p>		
Assessment:	National Trust Australia (Vic) Heritage Register:	No
	National Trust Australia (Vic) Criteria for Classification and Assessment:	Location or Context: Contribution to Landscape Historical Value
	MPS Heritage Overlay:	No
	Heritage Victoria Criteria for Classification and Assessment:	Referred for Assessment in Stage 2 of MRCC Heritage Study Part B
Field Description:	Tree Health:	Very Good
	Tree Structure & Condition:	Poor - Co-dominant or Bifurcated Stems
	Note:	Comments below
