2020

MRCC Significant Tree Register

***A Reference Guide to Significant Trees on Council
Land in the Municipality of Mildura***

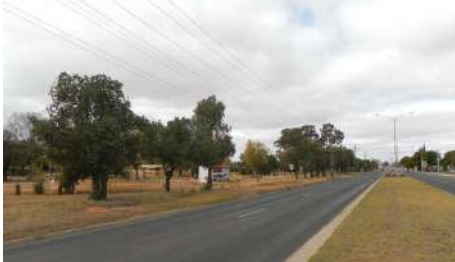
Identification:	Common Name:	Kurrajong		
	Genus & Species:	<i>Brachychiton populneus</i>		
	Tree Group Identifier No:	47		
	Tree No:	318-354

Location (Street Address or Park Name):	Holney Grove, Irymple (Holney Grove to Railway) Calder Highway, Irymple (South Bound)
			Access:	Unrestricted
			GIS Coordinates:	6211165.909 (N) / 607792.29200000002 (E)
<p><i>For mapping please refer to Tree Group Identification No 47 on Irymple (Key) town map in Appendix 1</i></p>				
Assessment:	National Trust Australia (Vic) Heritage Register:	No		
	National Trust Australia (Vic) Criteria for Classification and Assessment:	Location or Context: Contribution to Landscape		
	MPS Heritage Overlay:	No		
	Heritage Victoria Criteria for Classification and Assessment:	Referred for Assessment in Stage 2 of MRCC Heritage Study Part B		
Field Description:	Tree Health:	318-325, 327-331, 334-335, 337-354 Good 326, 332-333, 336 Poor

Tree Structure & Condition:	318-325, 328, 332-333, 336, 341, 343-344, 348, 352, 354 Poor - Co-dominant or Bifurcated Stems 326-327, 329-331, 334-335, 337-339, 342, 345-347, 349-351, 353 Good Structure 340 Poor - Lopped		
	Note:	Comments below		
	Dimensions:			
	Canopy (Planting Width/East West & North South Spread)	4m - 6m / EW 6m NS 5.5m		
	Measured Height:	9.6m		
	Measured DBH:	410E 390W		
	Overall Height Estimate:	3m - 6m		
Threats & Remedies:	Threats:	Overhead electric lines.		
	Remedial Action:	Monitor changes to Electric Line Clearance regulations which could impact the trees.		
Comments:	No comment required.

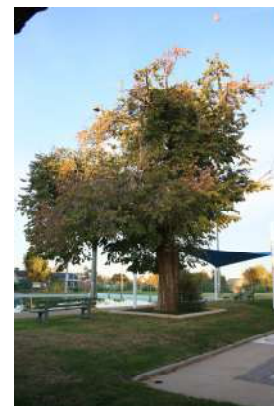
Identification:	Common Name:	Elm
	Genus & Species:	<i>Ulmus sp.</i>
	Tree Group Identifier No:	51
	Tree No:	372
Location & Access:	Location (Street Address or Park Name):	Merbein Swimming Pool, Merbein
	Access:	Access may be limited to times when pool is open to the public for use.
	GIS Coordinates:	6218929.6409999998 (N) / 597107.87399999995 (E)
<p><i>For mapping please refer to Tree Group Identification No 51 on Merbein (Key) town map in Appendix 1</i></p>		
Assessment:	National Trust Australia (Vic) Heritage Register:	No
	National Trust Australia (Vic) Criteria for Classification and Assessment:	Location or Context: Contribution to Landscape Rare or Localised
	MPS Heritage Overlay:	No
	Heritage Victoria Criteria for Classification and Assessment:	Referred for Assessment in Stage 2 of MRCC Heritage Study Part B
Field Description:	Tree Health:	Poor
	Tree Structure & Condition:	Good Structure
	Note:	Comments below

Dimensions:	Canopy (Planting Width/East West & North South Spread)	4m - 6m / EW 12m NS 11m
	Measured Height:	11m
	Measured DBH:	0.91m
	Overall Height Estimate:	3m - 6m
Threats & Remedies:	Threats:	Positioned in a high use area over the Summer period.
	Remedial Action:	Inspect tree regularly to manage risk associated with any part or whole tree failure in high use area.
Comments:	No comment required.	
	Assessment Completed by:	Gareth Tyson
	Assessment Completed date:	17 May 2012

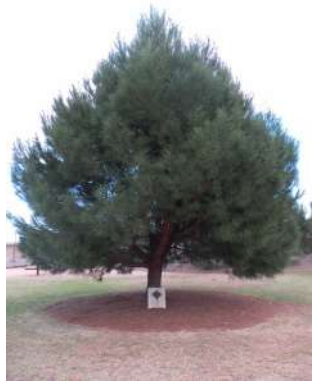
Identification:	Common Name:	Turkish Pine
	Genus & Species:	<i>Pinus brutia</i>
	Tree Group Identifier No:	54
	Tree No:	375
Location & Access:	Location (Street Address or Park Name):	Kenny Park, Merbein (Near Rotunda)
	Access:	Unrestricted
	GIS Coordinates:	6218935.54 (N) / 597221.5949999997 (E)

<i>For mapping please refer to Tree Group Identification No 54 on Merbein (Key) town map in Appendix 1</i>		
Assessment:	National Trust Australia (Vic) Heritage Register:	No
	National Trust Australia (Vic) Criteria for Classification and Assessment:	Location or Context: Contribution to Landscape Historical Value: World War 1
	MPS Heritage Overlay:	No
	Heritage Victoria Criteria for Classification and Assessment:	Referred for Assessment in Stage 2 of MRCC Heritage Study Part B
Field Description:	Tree Health:	Good
	Tree Structure & Condition:	Poor - Co-dominant or Bifurcated Stems
	Note:	No central leader resulting in current shape which is more like a large shrub than an upright tree.

Dimensions:	Canopy (Planting Width/East West & North South Spread)	4m - 6m / EW 8m NS 8m
	Measured Height:	9m
	Measured DBH:	0.48m @ 800mm from ground
	Overall Height Estimate:	3m - 6m
Threats & Remedies:	Threats:	As a result of the low and spreading branches as opposed to the central leader the tree will in time out grow its mulch ring and encroach on the adjoining lawn.
	Remedial Action:	Recommend that as the tree continues to grow the plaque be shifted from beneath the tree out further and the mulch ring be extended to eliminate the need for undertimming to allow for lawn maintenance.
Comments:	Plaque beneath the tree reads: <i>From the ORIGINAL LONE PINE ON GALLIPOLLI. Grown in the jubilee year 1965. Planted in memory of departed comrades LEST WE FORGET.</i>	
	Assessment Completed by:	Gareth Tyson
	Assessment Completed date:	29 June 2012

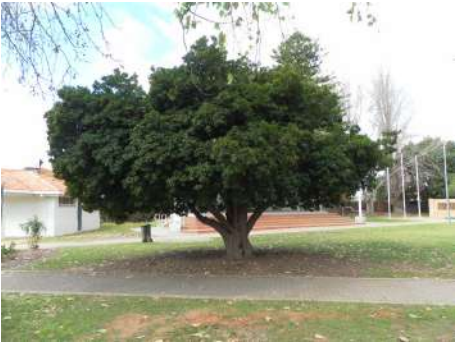
Identification:	<p>Common Name: Irish Strawberry</p> <p>Genus & Species: <i>Arbutus unedo</i></p> <p>Tree Group Identifier No: 60</p> <p>Tree No: 487</p>

Location & Access:	<p>Location (Street Address or Park Name):</p> <p>Access:</p> <p>GIS Coordinates:</p>	<p>Barclay Square, Red Cliffs</p> <p>Unrestricted</p> <p>6203118.784 (N) / 609282.79099999997 (E)</p>
Assessment:	<p>National Trust Australia (Vic) Heritage Register:</p> <p>National Trust Australia (Vic) Criteria for Classification and Assessment:</p> <p>MPS Heritage Overlay:</p> <p>Heritage Victoria Criteria for Classification and Assessment:</p>	<p>No</p> <p>Location or Context: Contribution to Landscape</p> <p>Tree covered by HO303 in the Mildura Planning Scheme</p> <p>Referred for Assessment in Stage 2 of MRCC Heritage Study Part B</p>
Field Description:	<p>Tree Health:</p> <p>Tree Structure & Condition:</p> <p>Note:</p>	<p>Good</p> <p>Good Structure</p> <p>Comments below</p>

Dimensions:	<p>Canopy (Planting Width/East West & North South Spread)</p> <p>Measured Height:</p> <p>Measured DBH:</p> <p>Overall Height Estimate:</p>	<p>4m - 6m / EW 9.3m NS 8.1m</p> <p>5.2m</p> <p>0.69 @ 0.3</p> <p>3m - 6m</p>
Threats & Remedies:	<p>Threats:</p> <p>Remedial Action:</p>	<p>Garden/lawn maintenance activities.</p> <p>Educate land managers about the suitable maintenance options in close proximity to the tree to minimise damage to any parts above or below ground.</p>
Comments:	<p>No comment required.</p> <p>Assessment Completed by:</p> <p>Assessment Completed date:</p>	<p></p> <p>Gareth Tyson</p> <p>29 June 2012</p>

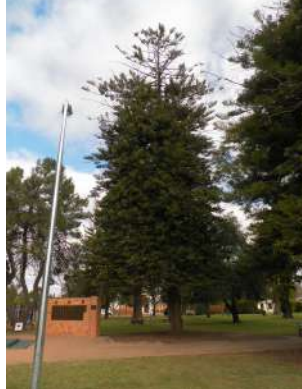
Assessment:	National Trust Australia (Vic) Heritage Register:	No		
	National Trust Australia (Vic) Criteria for Classification and Assessment:	Location or Context: Contribution to Landscape		
	MPS Heritage Overlay:	No		
	Heritage Victoria Criteria for Classification and Assessment:	Referred for Assessment in Stage 2 of MRCC Heritage Study Part B		
Field Description:	Tree Health:	Good		
	Tree Structure & Condition:	Good Structure		
	Note:	Comments below		
Dimensions:	Canopy (Planting Width)	4m – 6m		
	Tree No	Measured Height	Spread	Measured DBH
	488	20.4m	EW 11.3m NS 11.4m	0.67m
	489	20.8m	EW 9.3m NS 9m	0.65m
	490	18.6m	EW 8.9m NS 9.5m	0.51m
	491	17m	EW 6.7m NS 6.2m	0.44m
Threats & Remedies:	Threats:	488-490 Garden/lawn maintenance activities.		
		491 Proximity to play equipment.		
	Remedial Action:	Educate land managers about the suitable maintenance options in close proximity to the tree to minimise damage to any parts above or below ground.

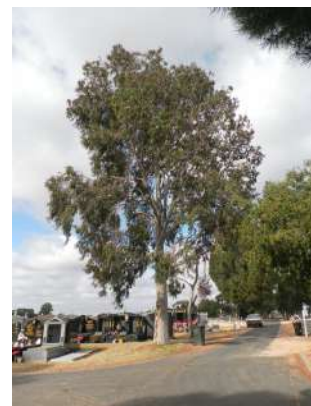
Identification:	Common Name:	Lemon Scented Gum
	Genus & Species:	<i>Corymbia citriodora</i>
	Tree Group Identifier No:	65
	Tree No:	507
Location & Access:	Location (Street Address or Park Name):	Nichols Point Cemetery, Nichols Point
	Access:	Unrestricted
	GIS Coordinates:	6215780.5949999997 (N) / 612187.973 (E)
<p><i>For mapping please refer to Tree Group Identification No 65 on Nichols Point (Key) town map in Appendix 1</i></p>		
Assessment:	National Trust Australia (Vic) Heritage Register:	No
	National Trust Australia (Vic) Criteria for Classification and Assessment:	Location or Context: Contribution to Landscape Aesthetic Value Historical Value
	MPS Heritage Overlay:	No
	Heritage Victoria Criteria for Classification and Assessment:	Referred for Assessment in Stage 2 of MRCC Heritage Study Part B
Field Description:	Tree Health:	Very Good
	Tree Structure & Condition:	Good Structure
	Note:	Comments below

Dimensions:	Canopy (Planting Width/East West & North South Spread)	4m - 6m / Not Assessed
	Measured Height:	Not Assessed
	Measured DBH:	Not Assessed
	Overall Height Estimate:	3m - 6m
Threats & Remedies:	Threats:	Compaction of site due to limited off road parking inside the cemetery grounds.
	Remedial Action:	Formalise site protection around the tree possibly including bollards and mulch.
Comments:	No comment required.	
	Assessment Completed by:	Gareth Tyson
	Assessment Completed date:	15 May 2012
